DEPRECIATION REPORT

FOREST'S EDGE 3 & 4

768 AND 788 ARTHUR ERICKSON
PLACE, WEST VANCOUVER

August 11, 2025

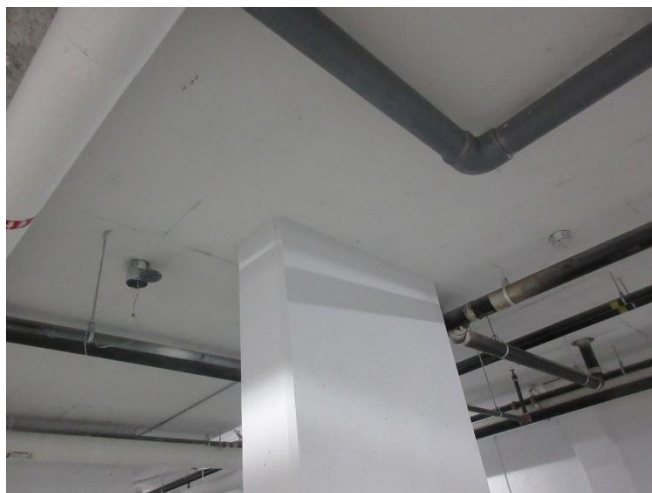
Most of the structural components are concealed from view. We did not see any evidence of unusual settlement, displacement or structural cracking in the areas we reviewed.

Photo 1: Typical structure in the parking garage.

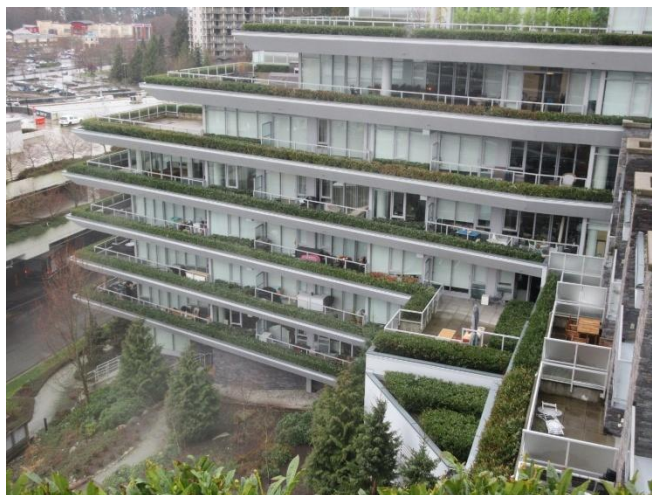
Photo 2: Typical balconies, roof decks and planters.

As part of this review we noted stains on the balcony and eyebrow slab edges at some locations. We expect that this can be addressed using funds from operating budgets.

The top and inner surfaces of the perimeter concrete guard walls at balconies and roof decks are generally not protected, contrary to the Architectural Drawings. This increases the potential for water leakage through cracks in the walls. In order to protect the concrete from leakage and prevent future deterioration, we have budgeted for waterproofing the top surfaces of the walls with a traffic deck coating, and painting the inner face of the walls, followed by similar programs of rewaterproofing and repainting in the future. The project budget is based on a quote received by the Strata and may not include engineering fees and contingencies.

We have budgeted to rewaterproof the balconies, roof decks, eyebrows and planters. The budget allocated for this includes allowances for local repairs to the concrete. We assume that any local areas that require repairs in the interim or between general repair/replacement projects will be funded out of operating budgets.

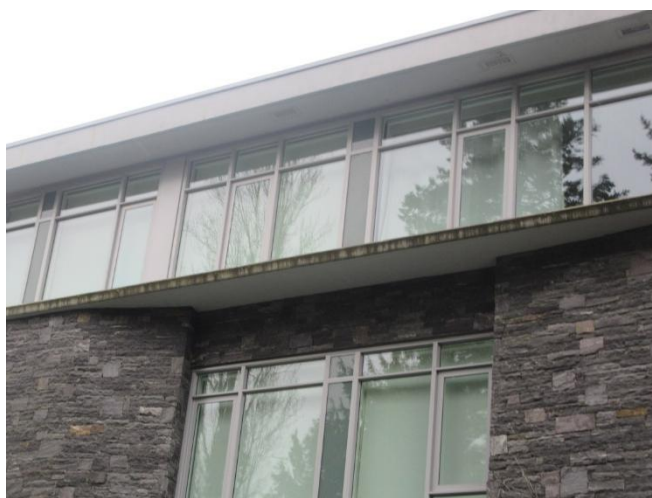
Photo 4: Typical eyebrow.

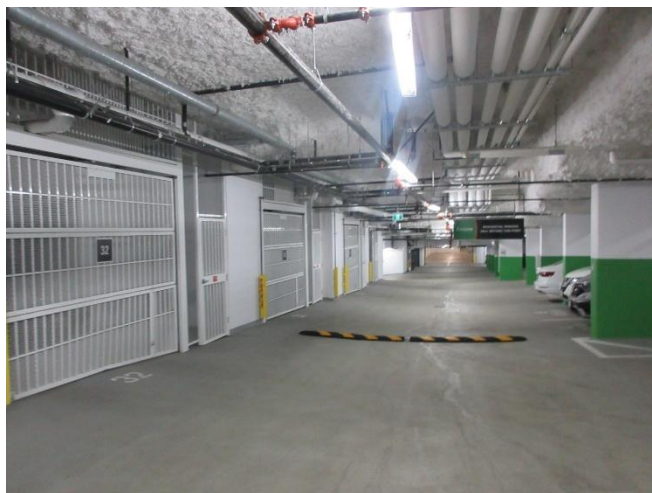
Photo 6: Parking garage.

- There is evidence of leakage in the form of efflorescence and/or water staining through cracks in the suspended slabs at some locations.
- The traffic deck coating is generally in good condition except at a few locations (typically around drains) where it has prematurely failed/peeled.

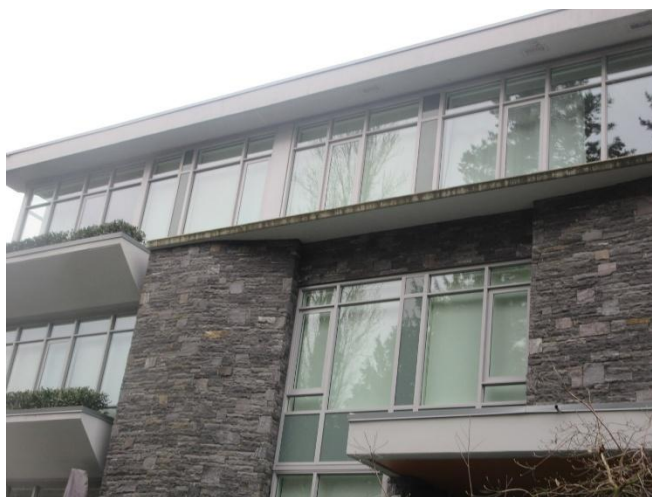
There are some defects related to the windows and balcony, roof deck and patio doors (i.e. conditions which should be addressed), that were noted as part of *Sense Engineering's* 5 Year Warranty Review Report. We assume that these conditions will be addressed by the Builder and/or Warranty Provider under warranty.

Photo 9: Typical exterior windows.

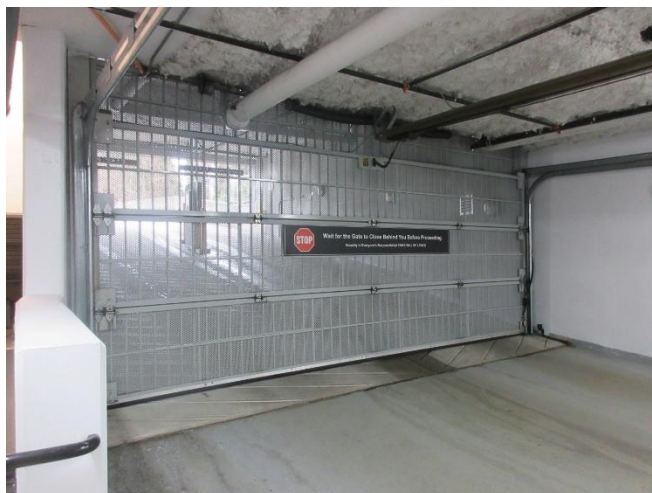
Photo 12: Garage overhead door.

We have budgeted for replacement of the parking garage and private parking stall overhead doors.

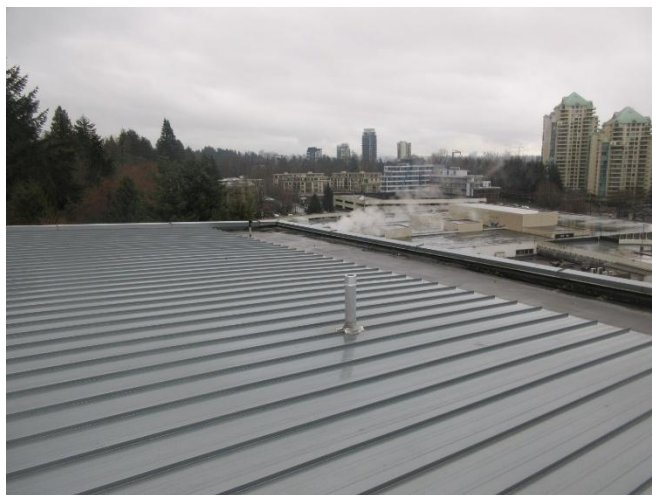
Photo 13: Typical sloped metal and exposed bitumen roof.

Exposed modified bitumen roofs in the Lower Mainland climate tend to have a serviceable life of about 20 years before they need to be replaced. Protected roof assemblies (such as with gravel ballast or concrete pavers) have an expected service life of about 25 to 30 years. These life expectancies assume proper materials were installed at the time of construction and proper application procedures were followed. The roofs are still relatively new and assuming proactive annual maintenance, we expect that they can be maintained in a serviceable condition to their expected service lives, possibly longer. However, their conditions should be monitored and replacement timing reconsidered as part of future updates to this Depreciation Report.
