DEPRECIATION REPORT

FOREST'S EDGE 3 & 4

768 AND 788 ARTHUR ERICKSON
PLACE, WEST VANCOUVER

August 11, 2025

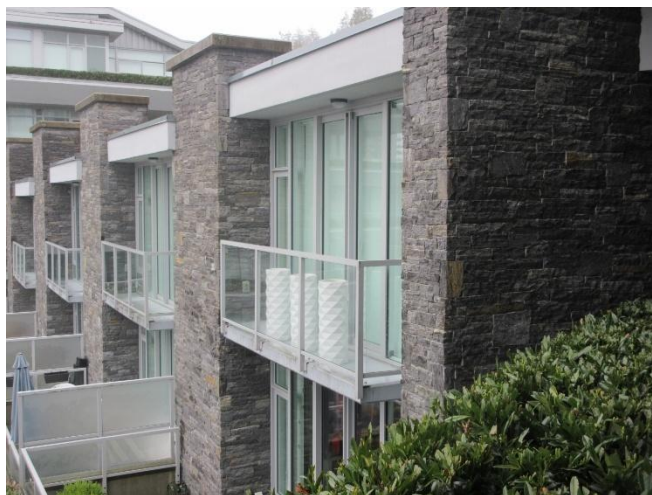
Photo 3: Typical townhouse unit balconies.

As part of this review we noted stains on the balcony and eyebrow slab edges at some locations. We expect that this can be addressed using funds from operating budgets.

We have budgeted to rewaterproof the balconies, roof decks, eyebrows and planters. The budget allocated for this includes allowances for local repairs to the concrete. We assume that any local areas that require repairs in the interim or between general repair/replacement projects will be funded out of operating budgets.

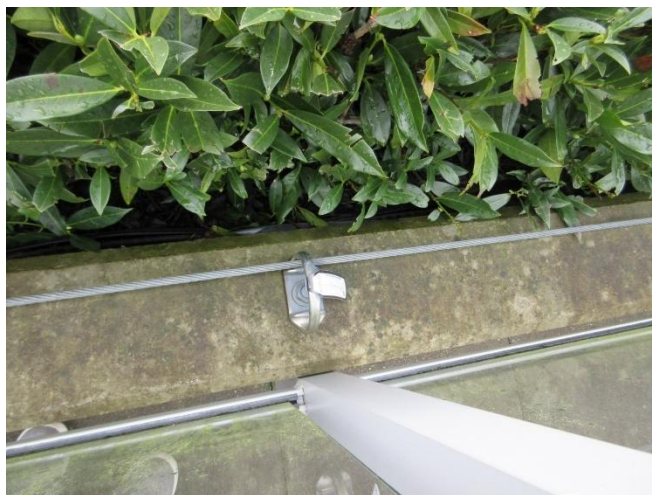
Photo 5: Typical anchor and horizontal lifeline.

We have not budgeted for the installation of additional anchors to permit suspended swing stage access to the exterior of the buildings. Instead, the projected costs of exterior repairs include higher costs to accommodate an alternative means of access.

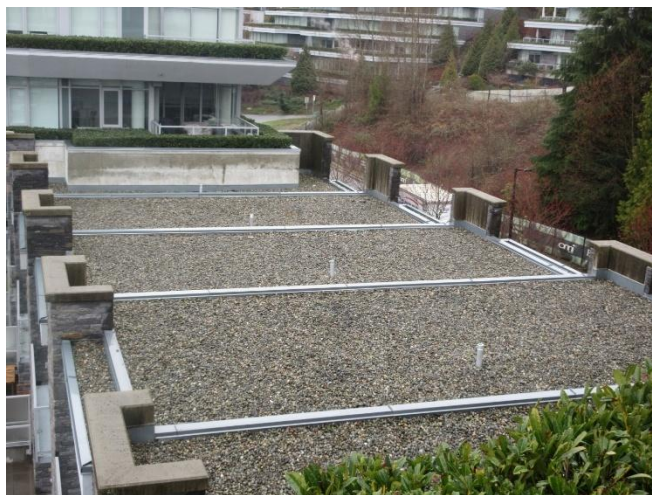
Photo 14: Ballasted roofs over the townhouses.

Exposed modified bitumen roofs in the Lower Mainland climate tend to have a serviceable life of about 20 years before they need to be replaced. Protected roof assemblies (such as with gravel ballast or concrete pavers) have an expected service life of about 25 to 30 years. These life expectancies assume proper materials were installed at the time of construction and proper application procedures were followed. The roofs are still relatively new and assuming proactive annual maintenance, we expect that they can be maintained in a serviceable condition to their expected service lives, possibly longer. However, their conditions should be monitored and replacement timing reconsidered as part of future updates to this Depreciation Report.

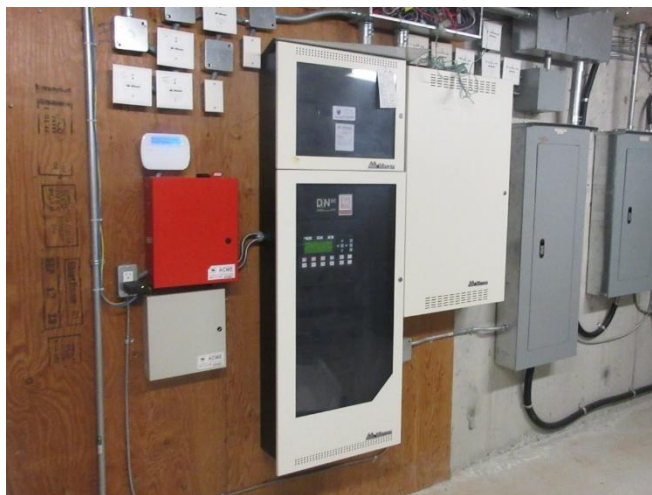
Photo 15: Typical fire alarm control and booster panels.

While the systems are still relatively new and presently performing well, we have budgeted for eventual replacement of the control panels and front-end systems. The project assumes that the panels will be replaced with similar, compatible systems such that the majority of the existing field devices and wiring can be reused. The replacement timing will depend on the performance of the systems and the service contractor's ability to continue to find replacement parts. The replacement cost will depend on what system components require replacing and what upgrades are necessary to meet Code requirements at the time. This should be re-evaluated as part of future updates to this Depreciation Report as further information from the service contractor and/or a life safety consultant are available.

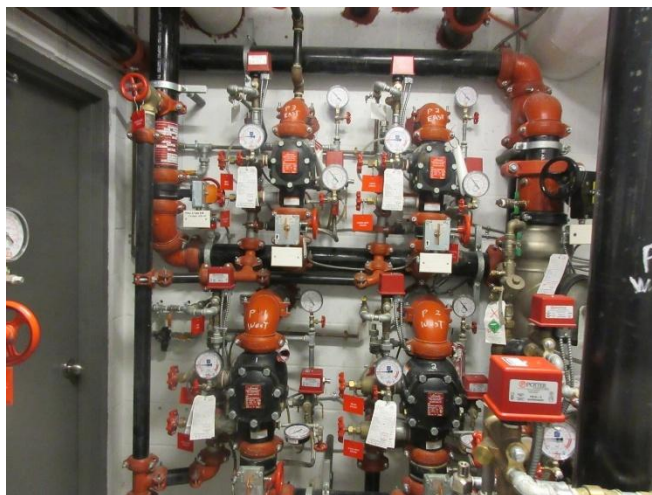
Dry-pipe systems are vulnerable to corrosion from the inside out. As such, we cannot determine the condition of the piping from a visual review alone.

Photo 17: Fire suppression equipment.

Repair and eventual replacement of the various individual components (e.g. valves, piping, sprinkler heads, etc.) should be expected. We assume this work, as well as other minor repairs identified by the annual testing and the testing itself, will be funded out of operating budgets.

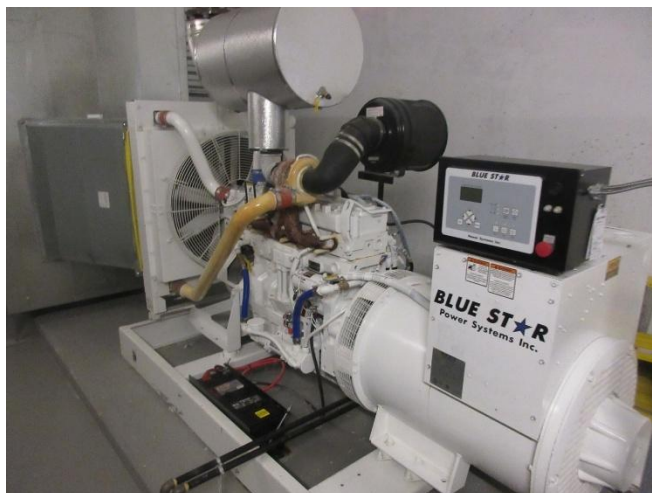
Photo 19: Emergency power generator.

Major manufacturers will typically not support older equipment, and we cannot predict how long replacement parts will remain available as components begin to fail. Based on the age of the unit, we have budgeted for an overhaul of the generator followed by eventual replacement of the generator, fuel tank and transfer switch.

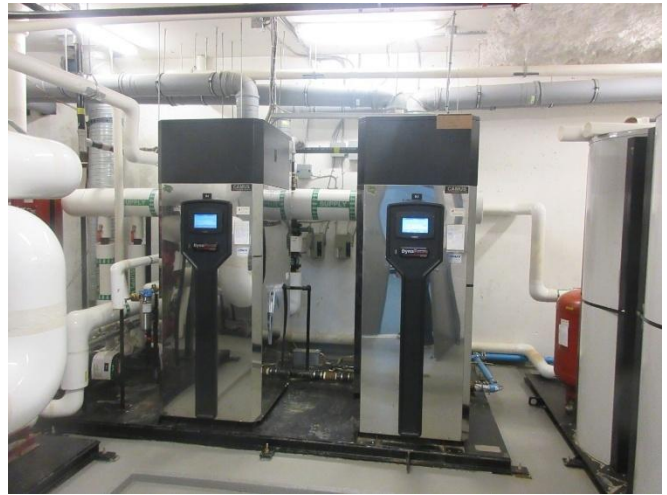
Photo 27: Heating boilers.

We have budgeted for overhauling the boilers, followed by eventual replacement. An overhaul is recommended at about the half-life of the boilers. This will help ensure a full/longer service life before the units have to be replaced. An overhaul would typically include taking the boiler apart, replacing any components that require replacement (including the burners, heat exchangers and/or gaskets, etc.), then rebuilding the boilers.

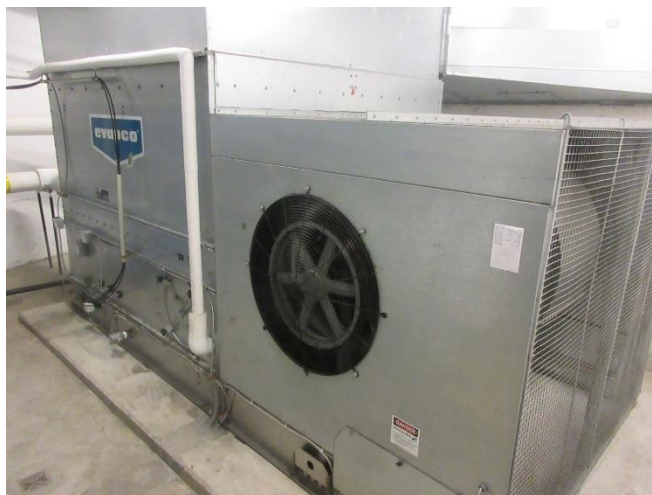
Photo 28: Cooling tower.

Cooling towers have a typical service life of about 25 to 30 years, although they can run much longer with diligent maintenance. We have budgeted for overhauling the cooling tower (which may include rebuilding of circulation pumps, repair/replacement of fans or other internal components like motors, compressors and spray nozzles, etc.), followed by eventual replacement.

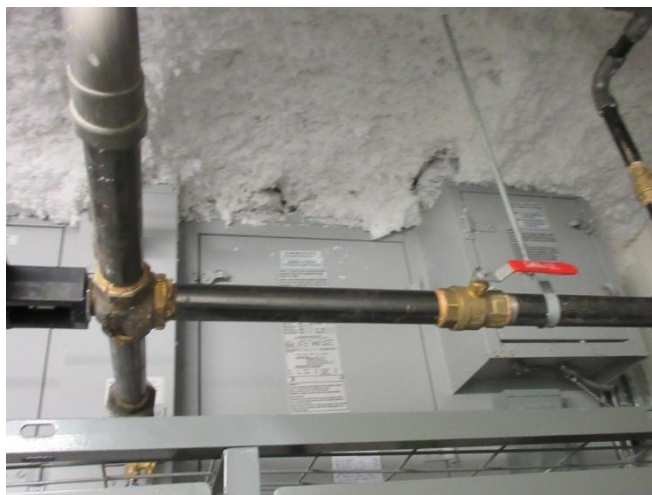
Photo 29: Typical make-up air unit.

This type of equipment has an expected service life of about 25 years. However, with proper maintenance, they can last much longer as many of the components can be changed without replacing the units outright, as long as the casings protect the interior components from getting wet. As the two units are located indoors, we expect that they can be maintained indefinitely by replacing individual components; therefore we have only budgeted for periodic overhauls.

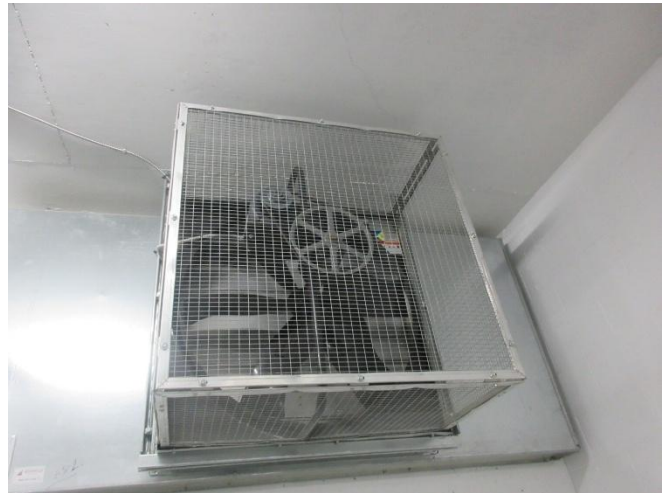
Photo 32: Typical garage exhaust fan.

We have budgeted for replacement of the garage and transformer room supply/exhaust fans. We have also budgeted for broadscale replacement of the gas detection sensors and control units at the end of their typical service lives.

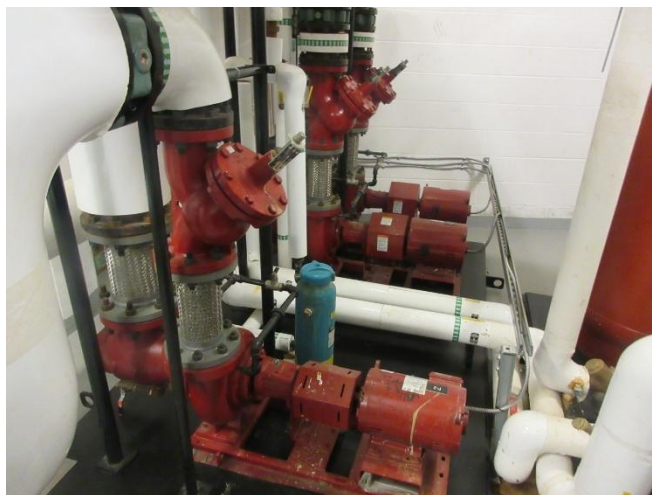
Photo 33: Heat pump and cooling loops circulation pumps.

We have budgeted to replace the circulation pumps (including associated VFDs) and the large expansion tanks. The project timing should be adjusted based on performances and budgets refined with the mechanical service contractor as the projects approach.

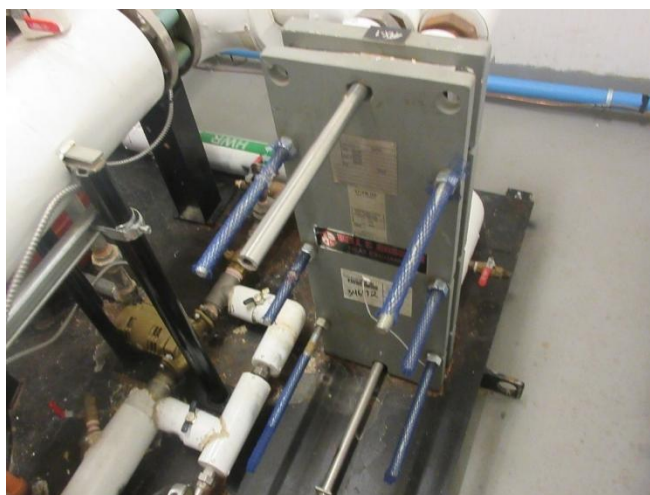
We have budgeted for replacing the heat exchanger and hot water storage tanks at the end of their typical service lives. The actual timing of the projects will depend on performance and should be adjusted in future updates to this Depreciation Report.

Photo 34: Heat exchanger.

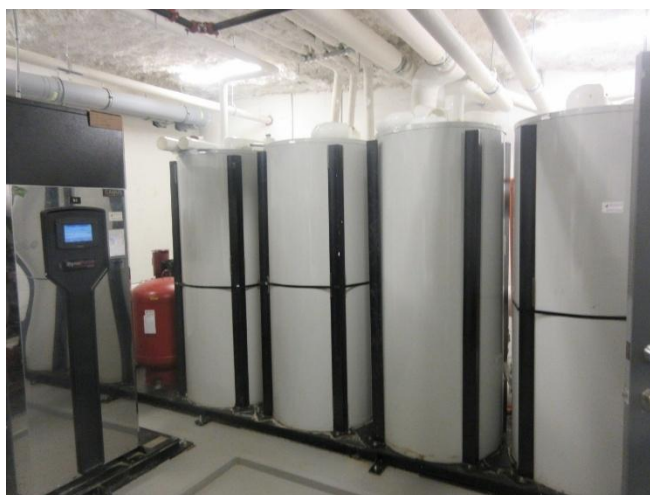
Photo 35: Hot water storage tanks.

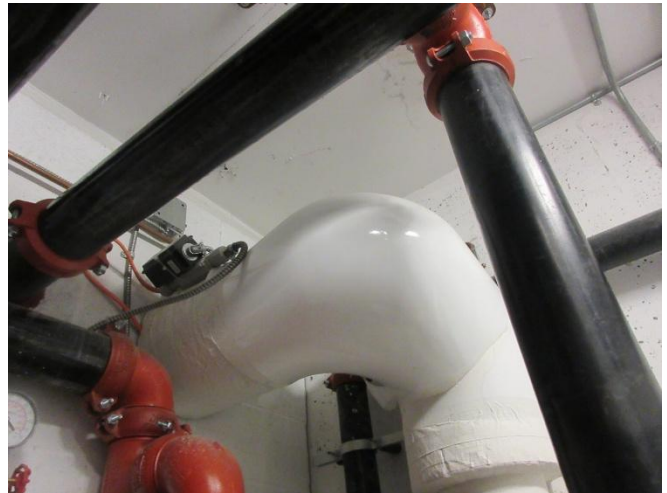
Photo 36: Combined incoming service.

We have budgeted for replacement of the larger backflow preventers on the domestic water and fire suppression lines.

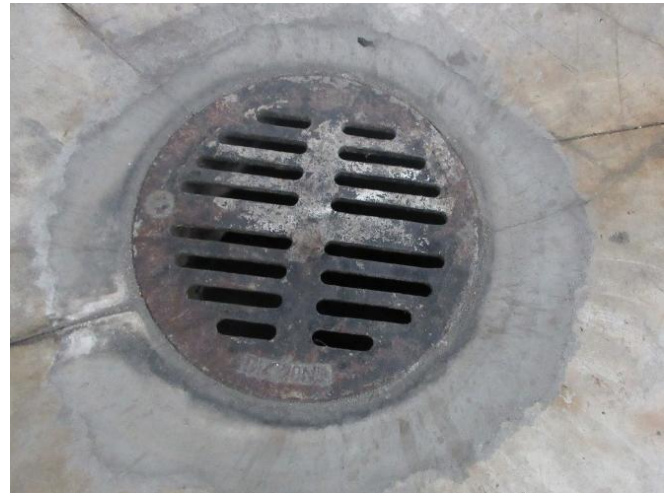
Garage internal drains, catch basins and trench drains are reasonably durable. We have budgeted for periodic replacement of the drains as part of suspended slab and garage roof slab waterproofing replacement projects (see the *Parking Garage* section of this report for further discussion and related budgets).

Photo 37: Typical catch basin.

The condition of the buried and concealed piping cannot be evaluated visually. We recommend that the drains and piping be cleaned, flushed and scoped routinely. This maximizes the service life of the piping and helps identify repair needs. We assume this will be done as part of ongoing maintenance.

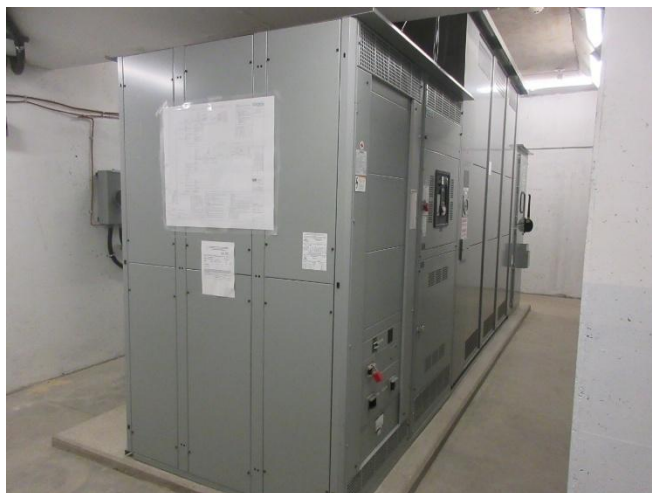
Photo 38: Electrical equipment.

Major electrical equipment has an average service life of 40 to 50 years or more. Given the age of the electrical equipment, we do not anticipate capital renewal within the report term. Replacement projects will need to be considered and brought into future updates to this Depreciation Report.

We recommend that all electrical panels and major equipment, including the electric charging station distribution panels and switches, be thermally scanned every three years as a minimum. This is to identify hot spots that require repair. The scans and related required repairs (such as minor tightening, etc.) are assumed to be funded out of the operating budgets.

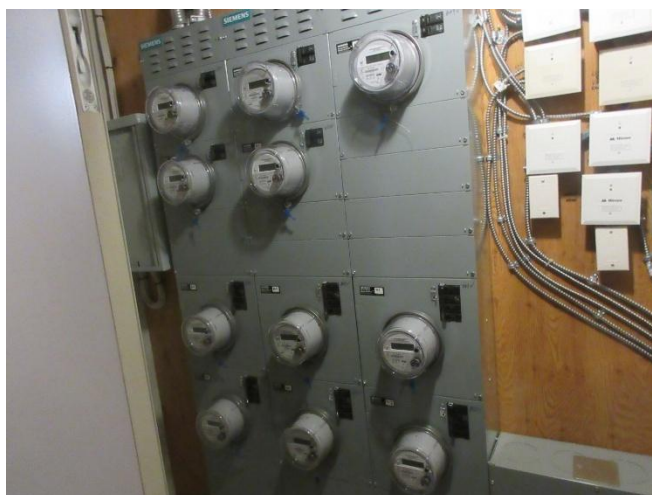
Photo 39: Typical suite meters.

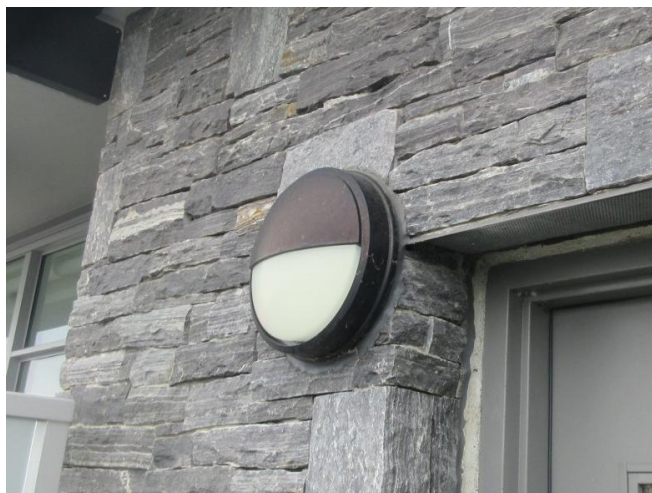
The lighting fixtures are in good condition, where reviewed. The current interior lighting levels appeared to meet minimum by-law requirements.

Photo 40: Typical exterior wall-mounted light.

We assume that replacement of the lighting systems will be carried out as needed as part of other projects, such as exterior wall repairs/ replacement, corridor and stairwell renovations, etc. We have included allowances accordingly in related projects.

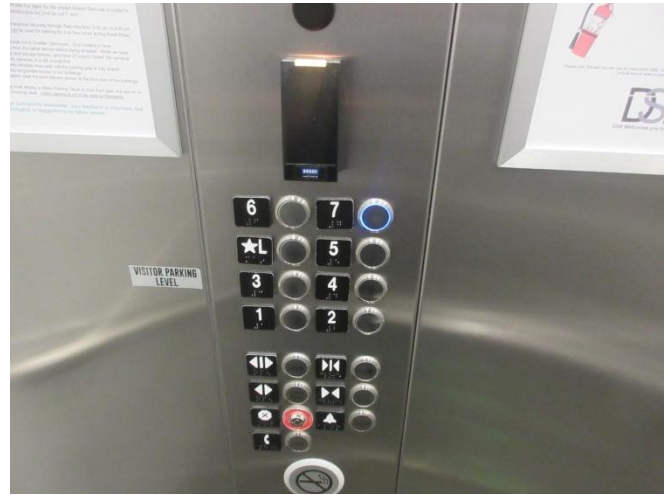
The design of MRL type elevators causes additional wear and tear to elevator hoist ropes. The elevator hoist location (at the top of the hoistway rather than in a separate elevator machine room) leads to additional bending stresses on the hoist ropes which can cause fatigue and eventual failure. Hoist rope wear is typically monitored as per elevator code requirements for minor strand breaks, loss of diameter tolerance and rouging. However, these signs are typically not present with MRL elevators, and wear is generally discovered as broken rope strands that make it necessary to replace all the hoist ropes. Hoist rope replacement is typically covered in the elevator contractor's service contract. However, replacement may lead to delays and longer periods of elevator downtime if the ropes are not proactively monitored and replaced.

Photo 41: Typical elevator button panel.

Based on the age of the systems, control modernization is likely to be required within the report term. Therefore, we have budgeted for modernization of the elevator controls. The budget includes an allowance for additional work that may be required as part of modernization, such as electrical, mechanical or fire alarm system upgrades. Costs may be higher depending on the extent of electrical, mechanical or fire alarm system upgrades required at the time of modernization.

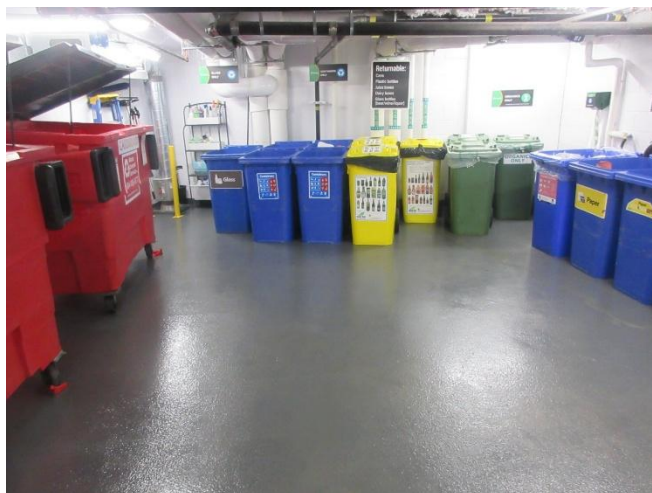
Photo 42: Typical waste and recycling bins.

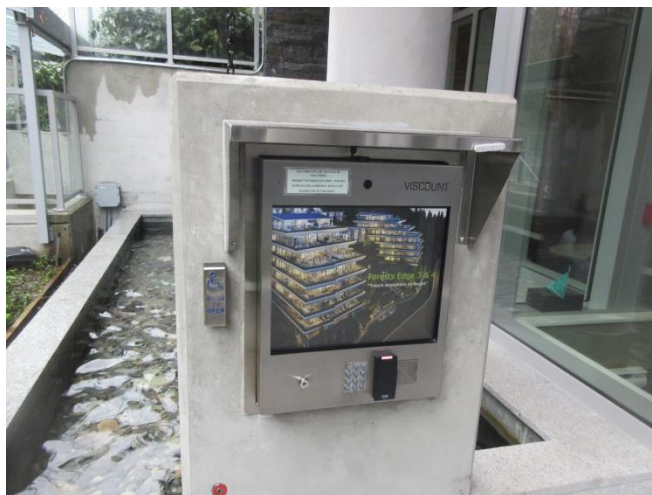
Photo 43: Typical enterphone panel and fob access reader.

We have budgeted for replacement of the enterphone panels at the end of their expected service life and upgrading the CCTV and fob systems. The replacement and upgrade timings are somewhat discretionary if the systems are still functioning, so this will need to be reconsidered as part of future updates to this Depreciation Report.
